REPAIR OF STONE MASONRY ARCH BRIDGES

Daniel V. Oliveira^{*} and Paulo B. Lourenço[†]

Key words: stone masonry, repair measures, architectural heritage

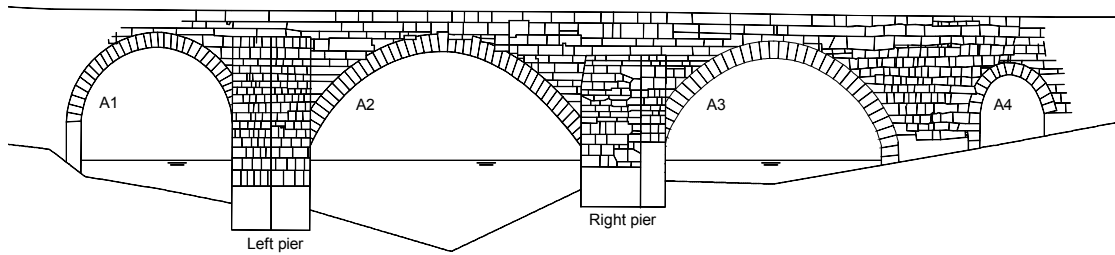
The bridge has a flat roadway, supported by three semicircular stone masonry arches, with different spans (6.6 m + 11.8 m + 9.4 m), as schematically illustrated in Figure 4. The bridge reaches a total length of 62.0 m and has a roadway width of 3.4 m. The central arch presents the larger span and it is supported by two massive piers, endowed with two triangular cutwaters at upstream and two rectangular cutwaters at downstream. On the right shore it is possible to find a flood arch, with a span of 2.7 m, constituting a 4th arch.

Figure 4: Donim bridge (upstream view)

The spandrel walls as well as the parapets were built with stone masonry, but successive maintenance works carried out over the years have changed some original characteristics as it can be noticed by the parapet wall partially rebuilt with concrete blocks and the granitic paving-stone pavement built during the 20th century.
